Project Site: White Meadow Lake**Date:** 8/11/2022**Weather:** Mostly sunny, wind from South/Southwest**Secchi Depth (meters/feet):** 0.8/2.62**Total Depth (meters/feet):** 2.1/6.89**Project number:** 0007.063**Field Team:** WK, PR**Water Color:** brown, cloudy**GENERAL OBSERVATIONS:**

IN-SITU DATA RESULTS**Table 1: In-Situ Data****In-Situ Monitoring for White Meadow Lake 8/11/22**

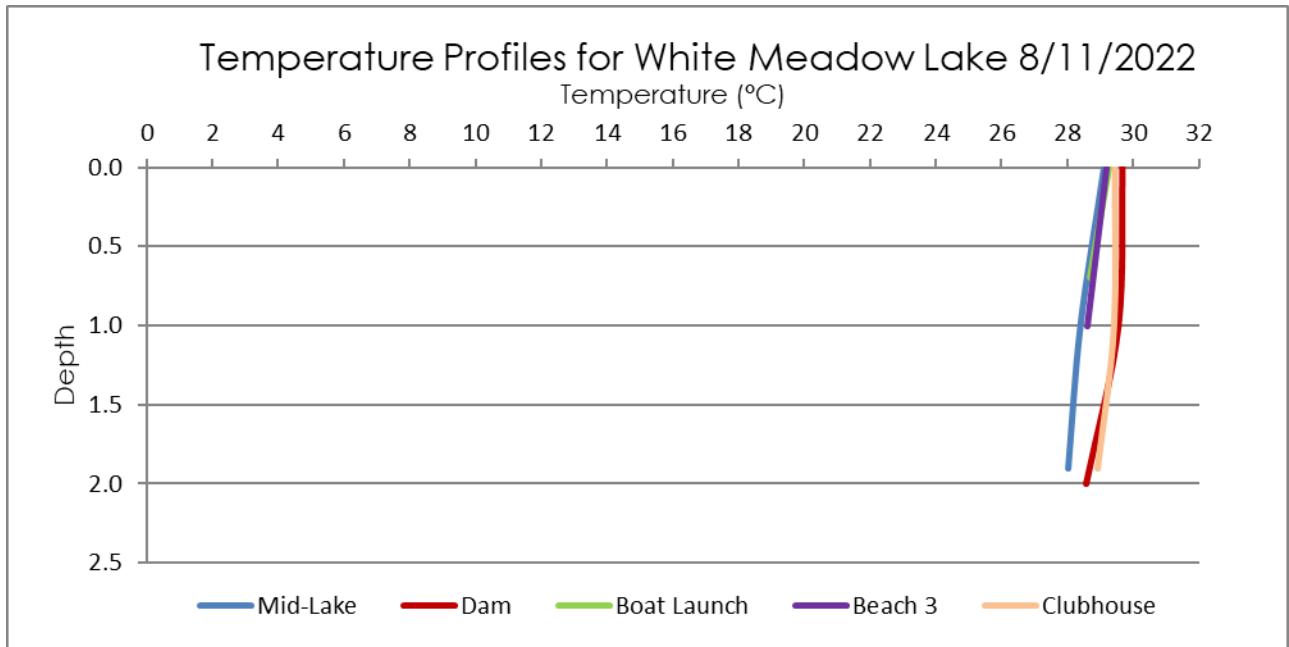
Figure 1: Temperature Profiles

Watercolor throughout the lake was noted as a cloudy brown color. Secchi depth readings were consistently 0.8 meters at all stations. Water level in the lake was lower than in previous monitoring events this year. Sparse-to-moderate-density southern naiad (*Najas guadalupensis*) was still the dominant species observed and was most dense at the Dam monitoring station. No filamentous algae mats were observed around the shoreline or in any portion of the lake. The water column at each station exhibited minimal changes in temperature and dissolved oxygen reduction. Once again, the bottom of the water column was not measured to be anoxic. Surface water temperatures were very warm, with the highest recorded value of 29.68 Celsius at the Dam station (Table 1). Warm water temperatures are likely a result of the recent hot air temperatures and brown coloration of the water column.
